62. TESTS OF WELDS IN TI-13V-11CR-3Al ALLOY SHEETS
FROM COMPANY A AND 2c TESTS OF AGE-STRENGTHENED
BASE METAL AND OF WELDS IN TI-6Al-4V AND
TI-13V-11CR-3Al ALLOY SHEETS FROM COMPANY F -
SUMMARY REVIEW OF FRACTURE TOUGHNESS RESULTS ON
TITANIUM ALLOYS BEING CONSIDERED FOR
SOLID-PROPELLANT ROCKET MOTOR CASES

H. E. Romine
Warhead and Terminal Ballistics Laboratory

NWL Report No. 1798

30 March 1962

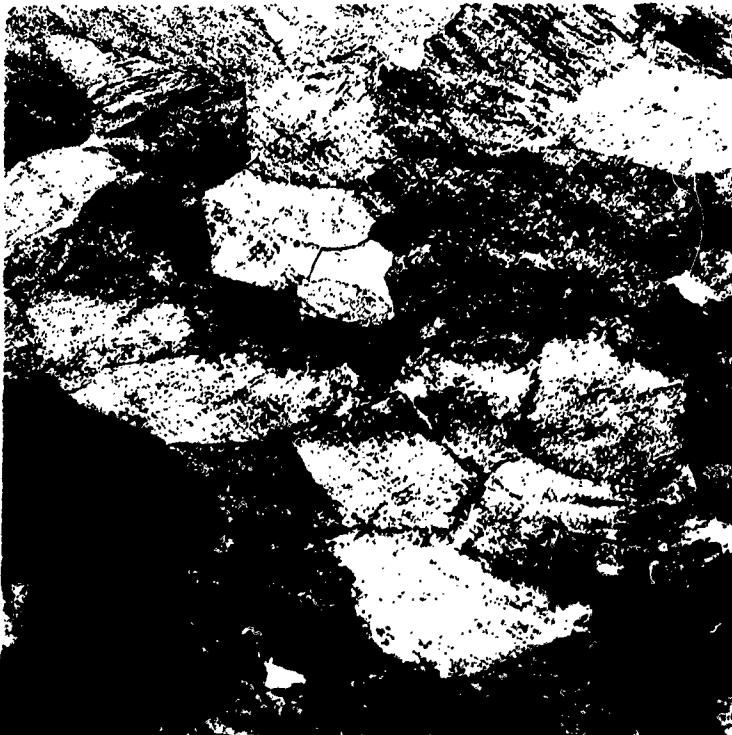
Company F Samples. Unwelded samples of high-strength base metal and welded samples of alpha-beta Ti-6Al-4V alloy and of all-beta Ti-13V-11Cr-3Al alloy were tested. The K_{Ic} specimen layouts are shown in Figure 7. Microstructures of the high-strength (solution-treated and aged) condition of the alloys are represented in Figure 8.

- (A) Ti-6Al-4V Alloy;
hot rolled, solution
treated and aged
condition. ASTM
micro grain size
number 10. Hardness
375 Vickers DPH (10 kg).
"C" etch, X250.

- (B) Ti-13V-11Cr-3Al alloy;
hot rolled, solution
treated and aged
condition. ASTM
micro grain size
number 1-2. Hardness
388 Vickers DPH (10 kg).
"C" etch, X100.

MICROSTRUCTURE IN UNWELDED HEAT TREATED BASE METAL SAMPLES OF
TITANIUM ALLOYS FROM COMPANY F

("C" etch contains 1 ml HF, 25 ml HNO_3 , 3 grams $\text{Pb}(\text{NO}_3)_2$
and water to make 100 cc)
